FIRE TEST REPORT

FR12837-01-2

**FIRE RESISTANCE TEST OF A LOADBEARING STEEL
JOIST FLOOR AND 36 MM METRA PANEL CEILING
CONSTRUCTION IN ACCORDANCE WITH
AS 1530.4:2014**

Metra Systems Limited
15 Tregowerth Lane
Huntly
New Zealand

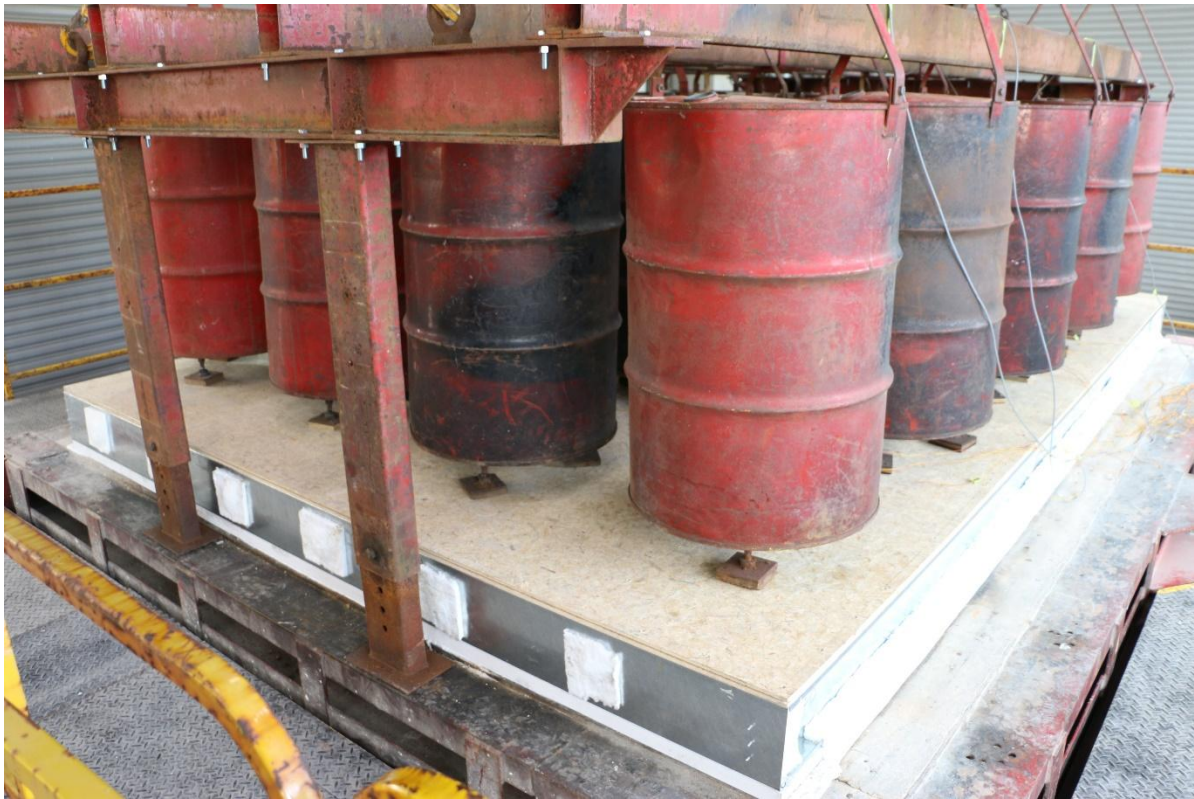
Photo 1: The Construction Including Loading Apparatus Prior to Testing

At the request of the client a uniformly distributed load of 3.0 kPa was placed on the specimen. The load was applied using 20 drums partially filled with water and approximately uniformly distributed over the top of the specimen. Each drum had three swivel feet, each with a contact surface consisting of a 100 mm x 100 mm square of particleboard. The load was applied to the specimen at least 30 minutes before the commencement of the test.

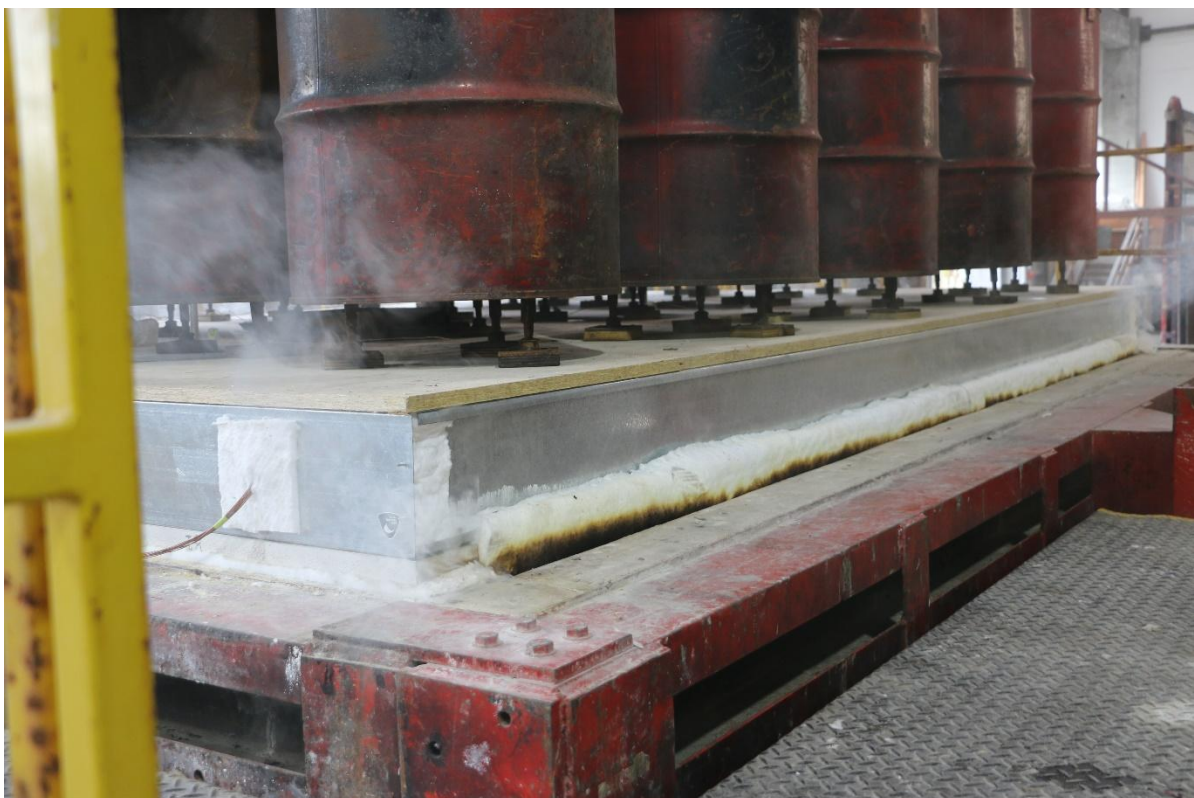
Photo 2: The Test Construction After a Duration of 20 Minutes

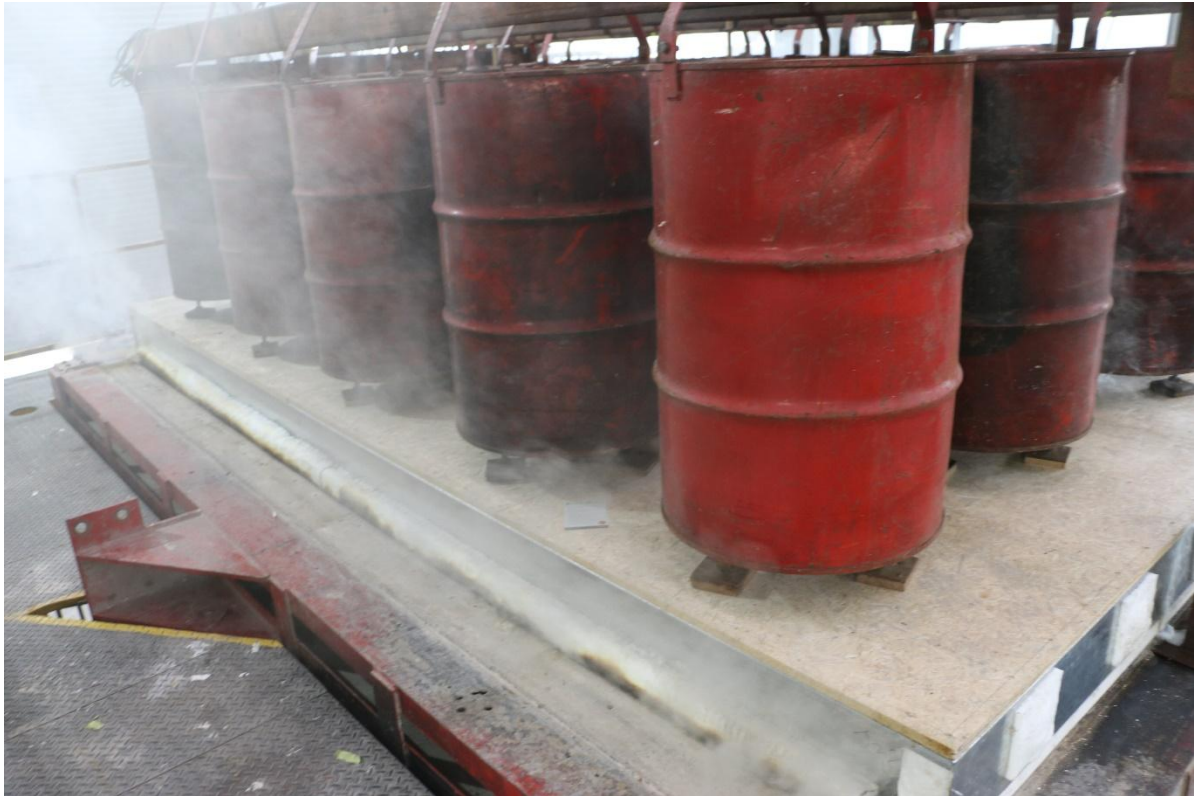
Photo 3: The Test Construction After a Duration of 40 Minutes

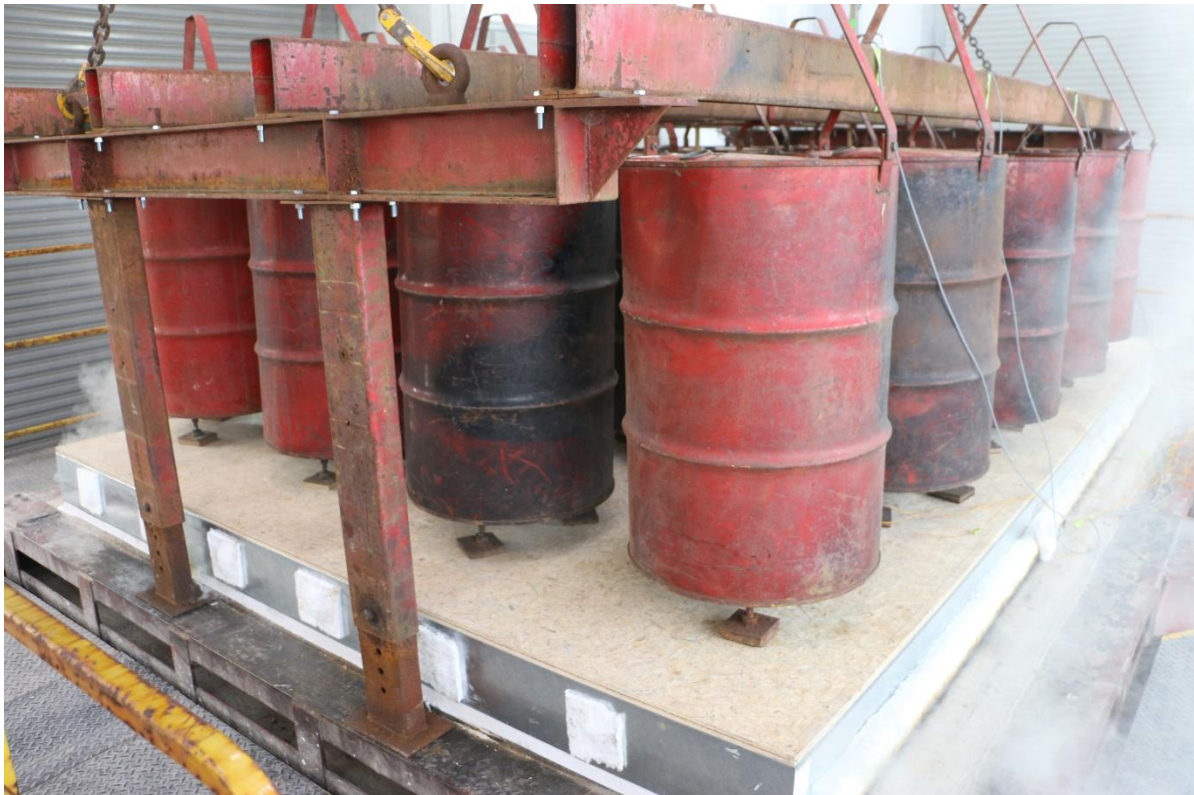
Photo 4: The Test Construction After a Duration of 60 Minutes
