# **FIRE TYPE TEST REPORT**

## **FR12837-001**

### **FIRE RESISTANCE TEST OF A LOADBEARING STEEL JOIST FLOOR AND 36 MM METRA PANEL CEILING CONSTRUCTION IN ACCORDANCE WITH AS 1530.4:2014**

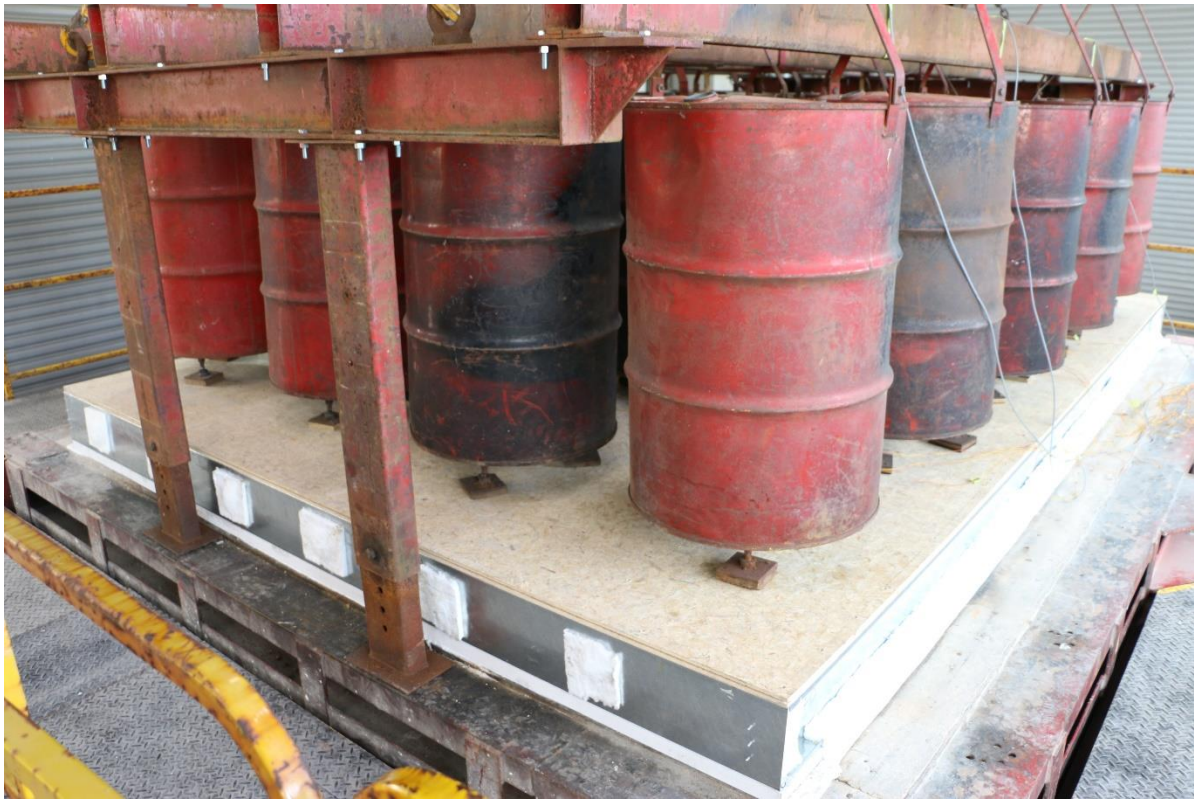
Photo 1: The Construction Including Loading Apparatus Prior to Testing

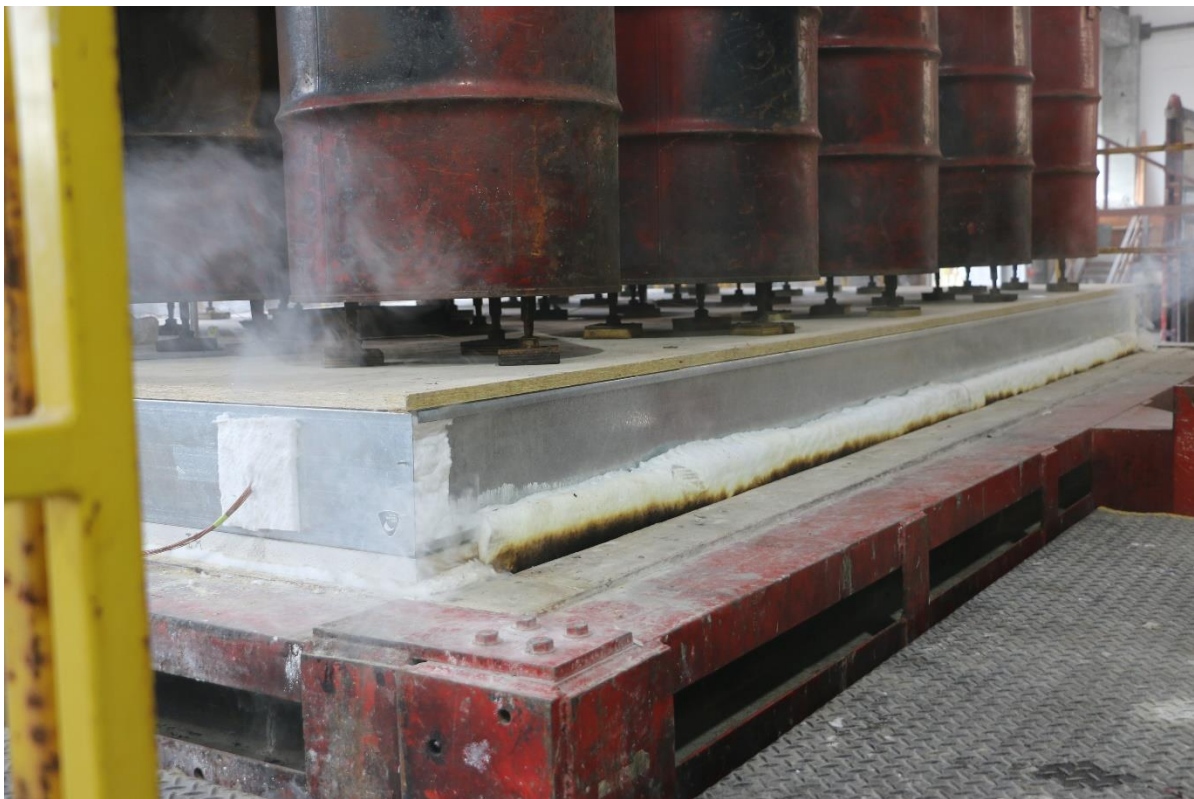
Photo 2: The Test Construction After a Duration of 20 Minutes

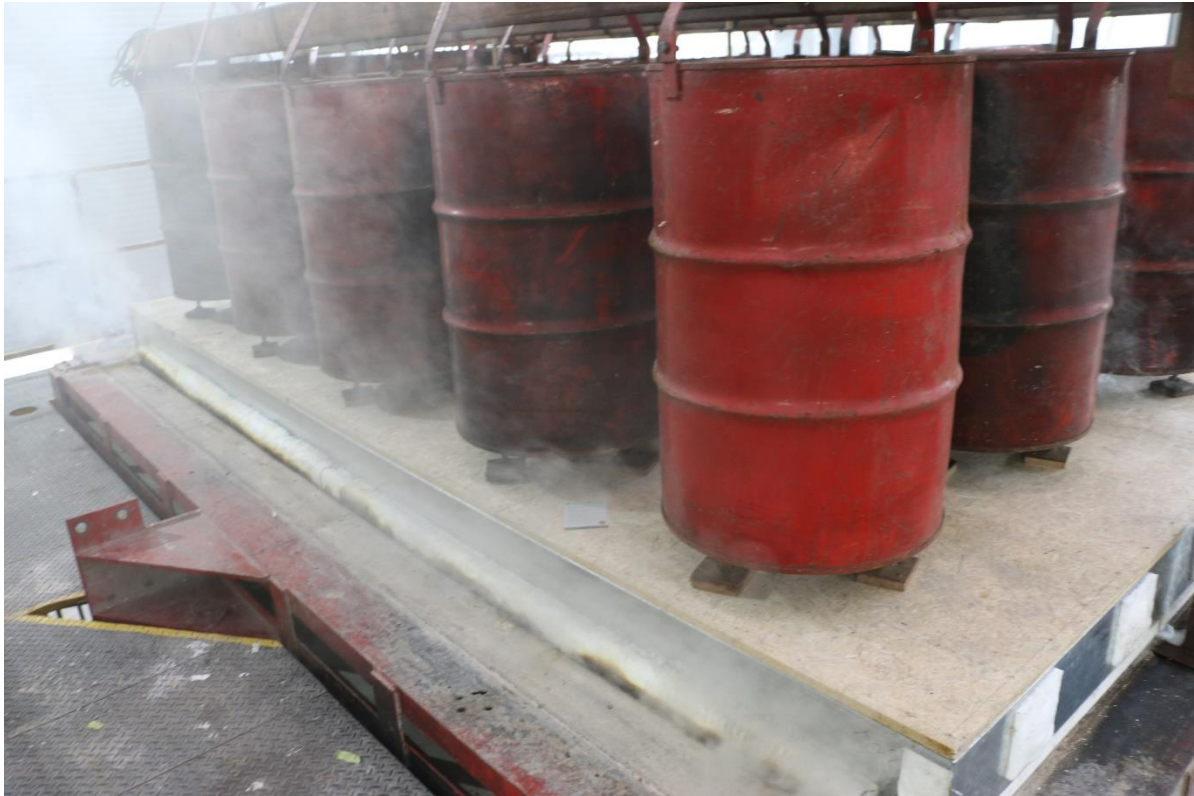
**Photo 3: The Test Construction After a Duration of 40 Minutes**

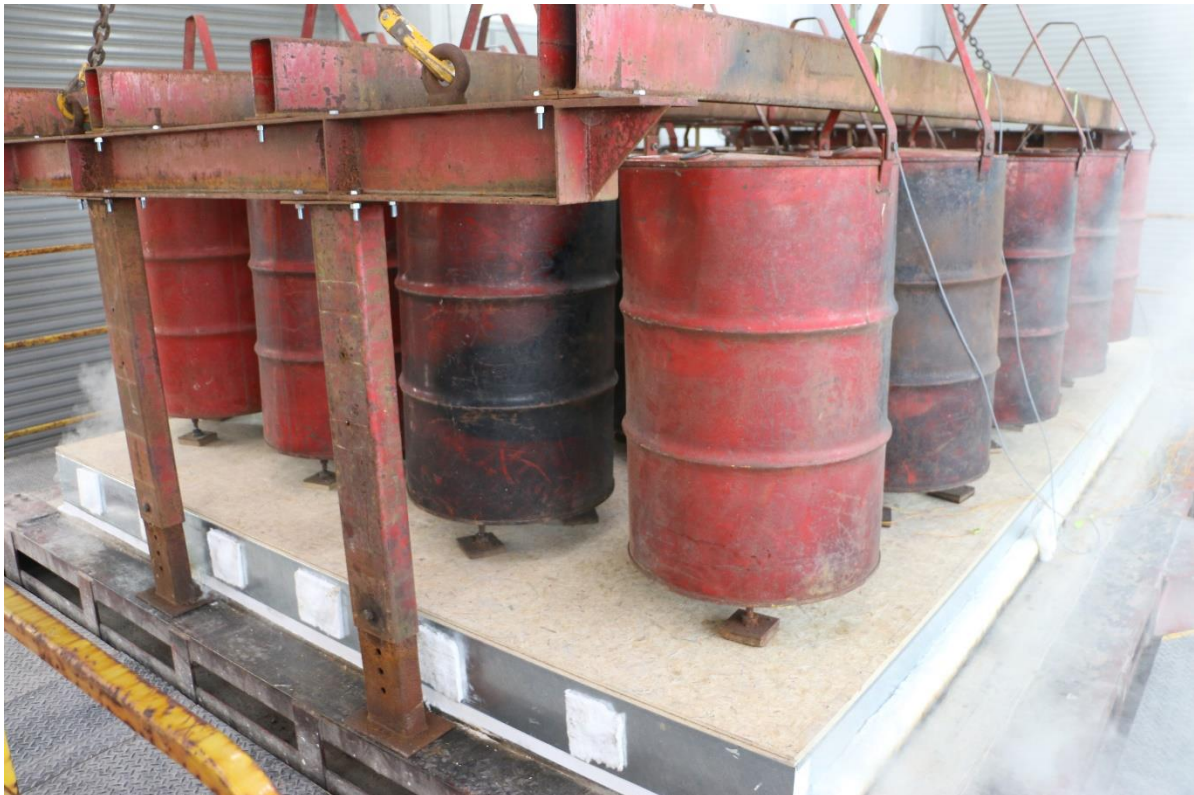
**Photo 4: The Test Construction After a Duration of 60 Minutes**
